INDOOR AIR QUALITY ASSESSMENT

**Julia Bancroft Elementary School
3 Vinal Street
1956 Wing
Auburn, Massachusetts**

Prepared by:
Massachusetts Department of Public Health
Center for Environmental Health
Bureau of Environmental Health Assessment
Emergency Response/Indoor Air Quality Program
May 2004

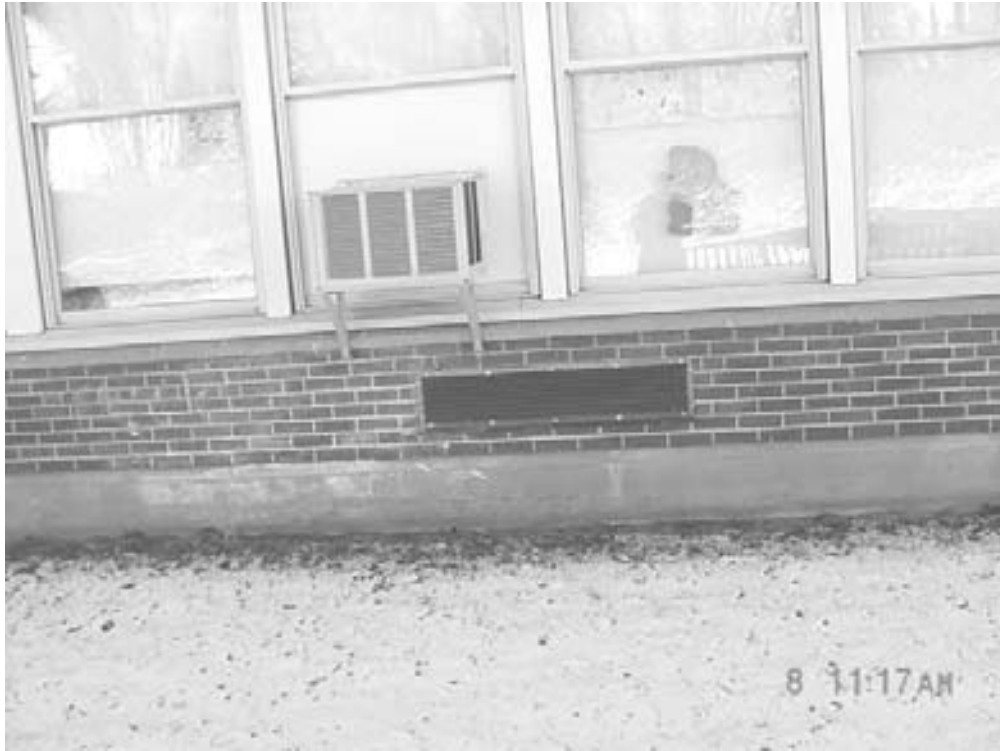
Picture 1

It can be seen from Table 1 that carbon dioxide levels were above 800 parts per million parts of air (ppm) in all areas surveyed, indicating inadequate air exchange throughout the school on the day of the assessment. Fresh air in classrooms is supplied by a unit ventilator (univent) system. Univents are designed to draw air from outdoors through a fresh air intake located on the exterior walls of the building (Picture 1) and return air through an air intake located at the base of each unit ([Figure 1](#)). Fresh and return air are mixed and filtered, then heated and provided to classrooms through a fresh air diffuser located in the top of the unit. Univents are reportedly original equipment, approximately 40-50 years old. Univents of this age are difficult to maintain because replacement parts are often unavailable. Most the univents were operating during the assessment. The univent in classroom 5 had been deactivated by the occupant, due to noise. Obstructions to airflow, such as papers and books stored on univents and bookcases, carts and desks in front of univent returns, were seen in a number of classrooms (Pictures 2 and 3). In order for univents to provide fresh air as designed, units must remain activated and allowed to operate while these rooms are occupied. Intakes must also remain free of obstructions.

Univent Fresh Air Intake 1956 Wing

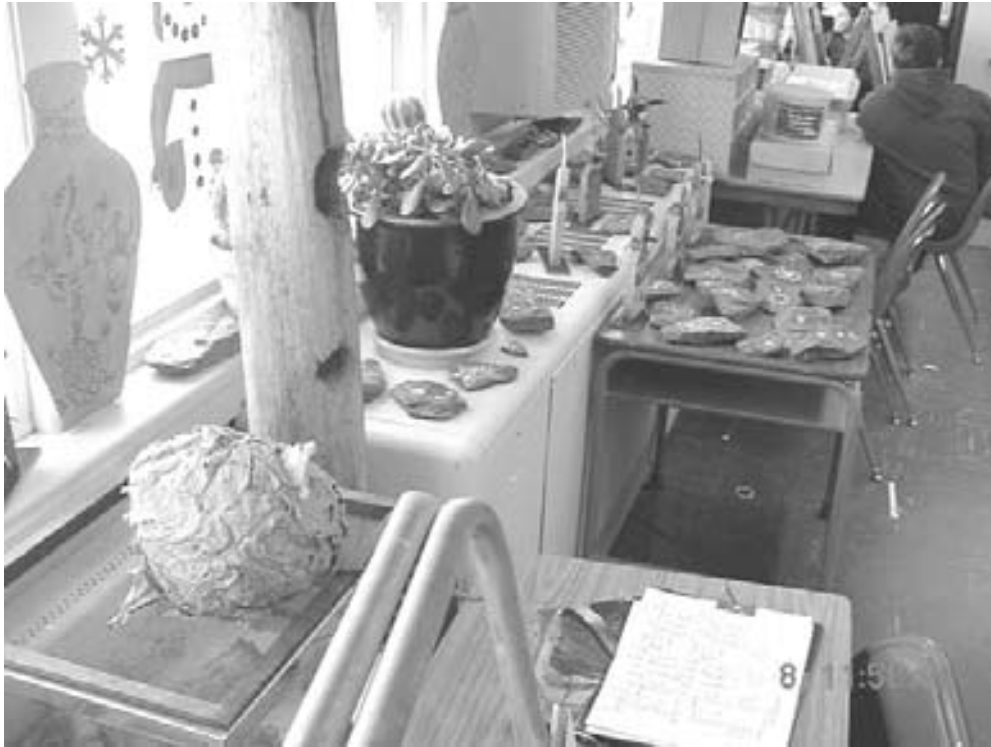
Picture 2

Plants were noted in several classrooms. Plants can be a source of pollen and mold, which can be respiratory irritants for some individuals. Plants should be properly maintained and equipped with drip pans. Plants should also be located away from univents to prevent the aerosolization of dirt, pollen or mold (Picture 2).

Plants and Other Items on and In Front of Classroom Univent

9. Move plants away from univents in classrooms. Avoid over-watering and examine drip pans periodically for mold growth. Disinfect with an appropriate antimicrobial where necessary.

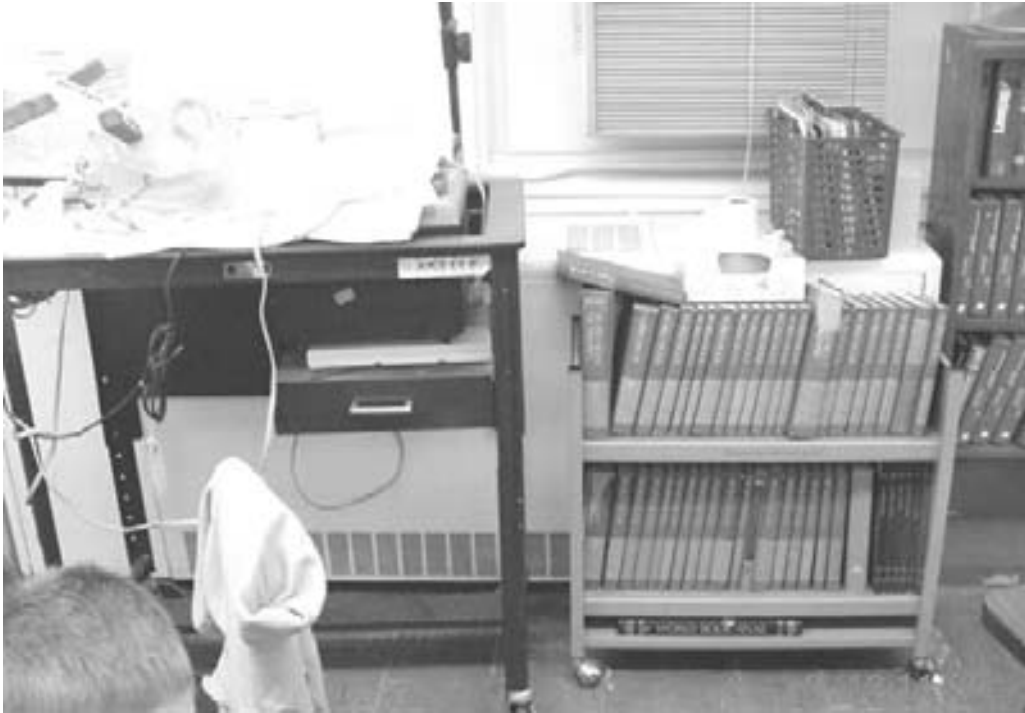
Picture 3

Items Obstructing Univent Airflow in Classroom

5. Remove all blockages from univents and exhaust vents to ensure adequate airflow.
6. Consider having ventilation systems re-balanced every five years by an HVAC engineering firm.

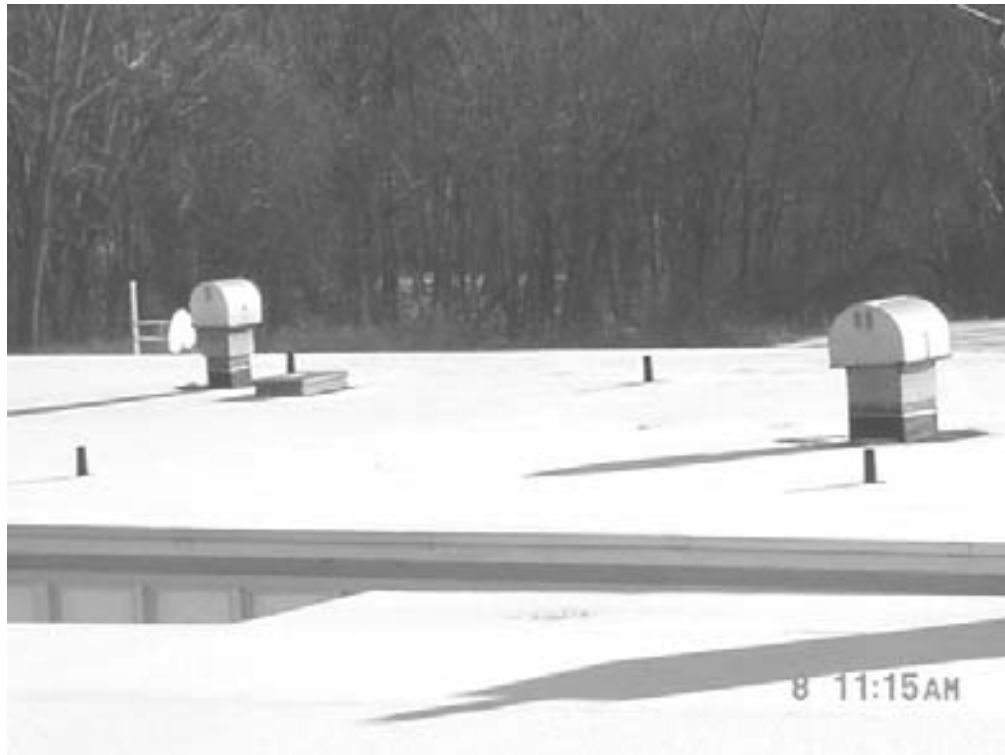
Picture 4

Exhaust ventilation in classrooms is provided by a mechanical system. The exhaust system in each classroom consists of ducted, grated wall vents. Classroom air is drawn out of the indoor environment by rooftop motors (Picture 4). A number of exhaust vents were not operating, or were operating weakly and/or backdrafting, indicating that motors were deactivated or non-functional. In addition, desks, bookcases, shelving and other items (Pictures 5 and 6) blocked a number of the vents in both buildings. As with the univents, in order to function properly, exhaust vents must be activated and remain free of obstructions.

Rooftop Exhaust Vents 1956 Wing

3. Set the thermostat for modular classrooms to the fan “on” position to operate the ventilation system continuously during the school day.
4. Inspect exhaust motors and belts for proper function. Repair and replace as necessary.

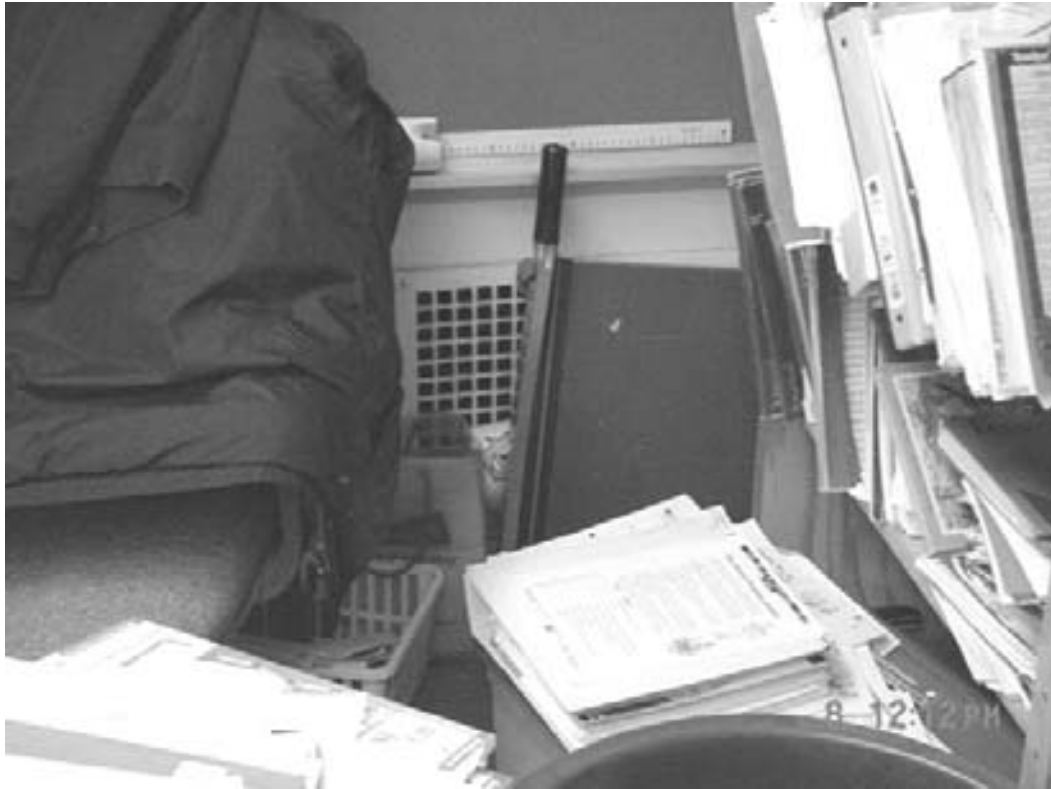
Picture 5

Classroom Exhaust Vent Obstructed by Various Items

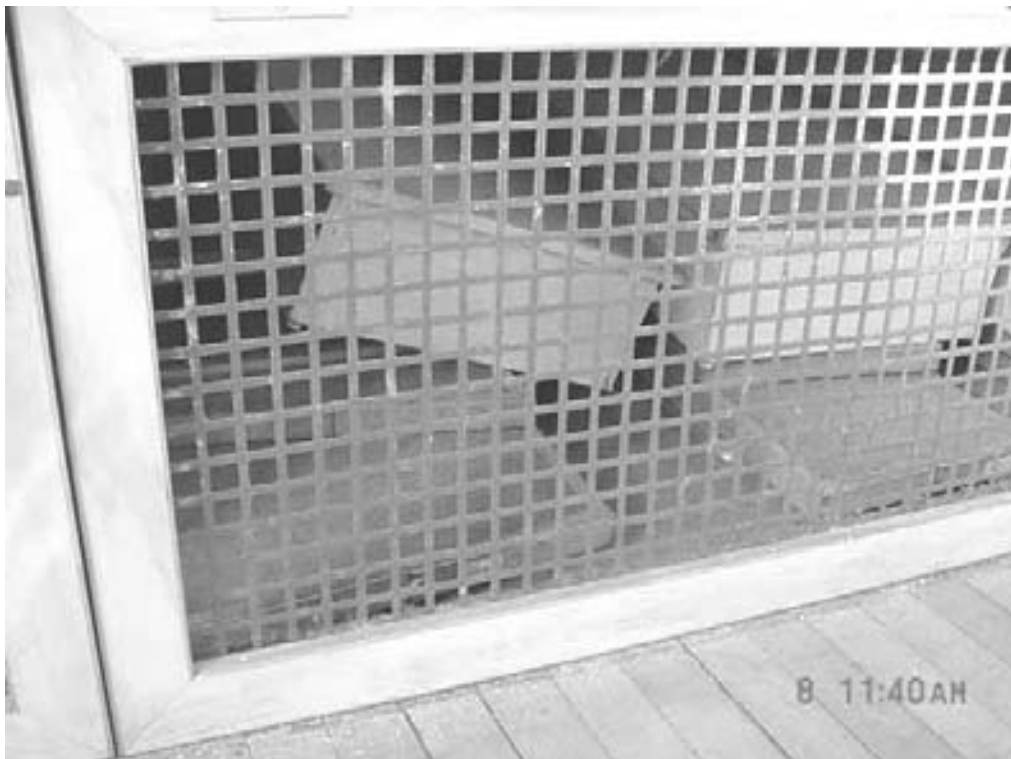
Picture 6

Items Stored Under Stage Obstructing Airflow Into Vent

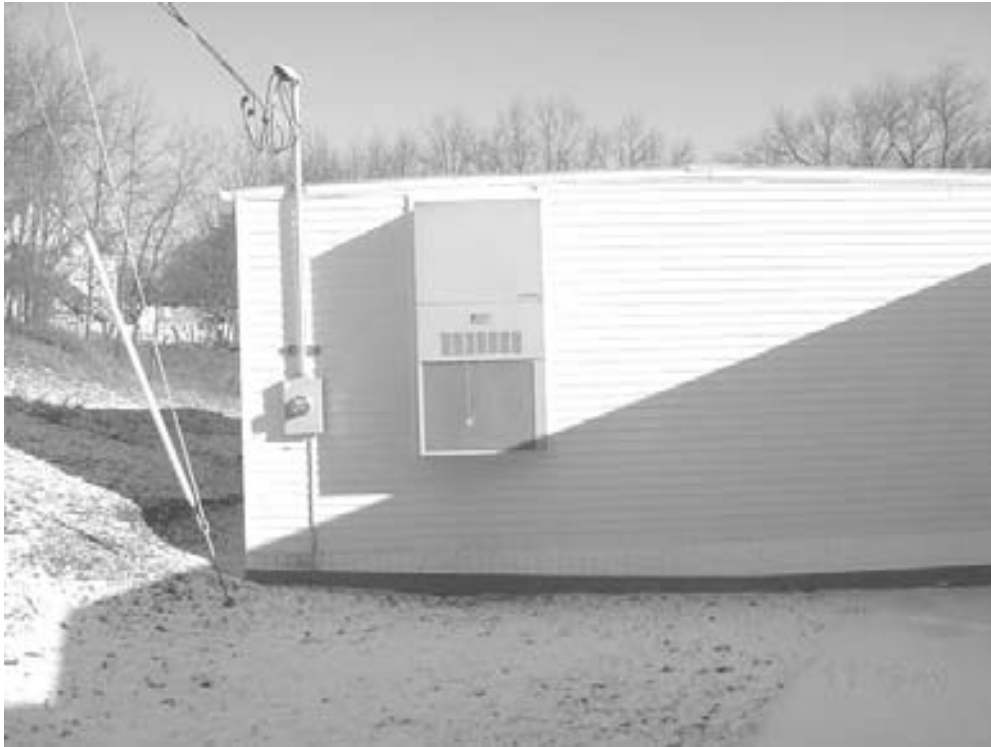
Picture 7

Ventilation for modular classrooms is provided by AHUs mounted on the exterior of the building (Picture 7). Fresh air is distributed to classrooms via ductwork connected to ceiling-

AHU for Modular Unit

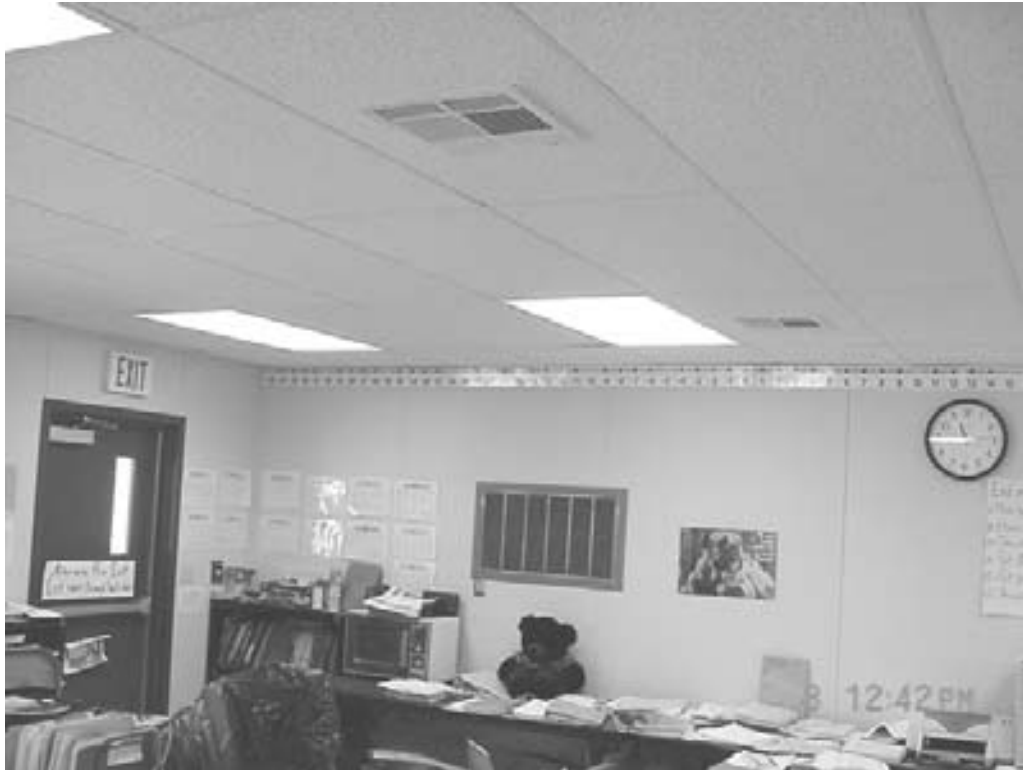
Picture 8

mounted air diffusers. Return vents draw air back to the units through wall-mounted grilles (Picture 8). Thermostats control each heating, ventilating and air conditioning (HVAC) system and have fan settings of “on” and “automatic”. Thermostats were set to the “automatic” setting (Picture 9) in all of the modular rooms surveyed during the assessment. The automatic setting on the thermostat activates the HVAC system at a preset temperature. Once the preset temperature is reached, the HVAC system is deactivated. Therefore, no mechanical ventilation is provided until the thermostat re-activates the system.

Ceiling Mounted Supply Vent and Wall Mounted Return Vent in Modular Classroom

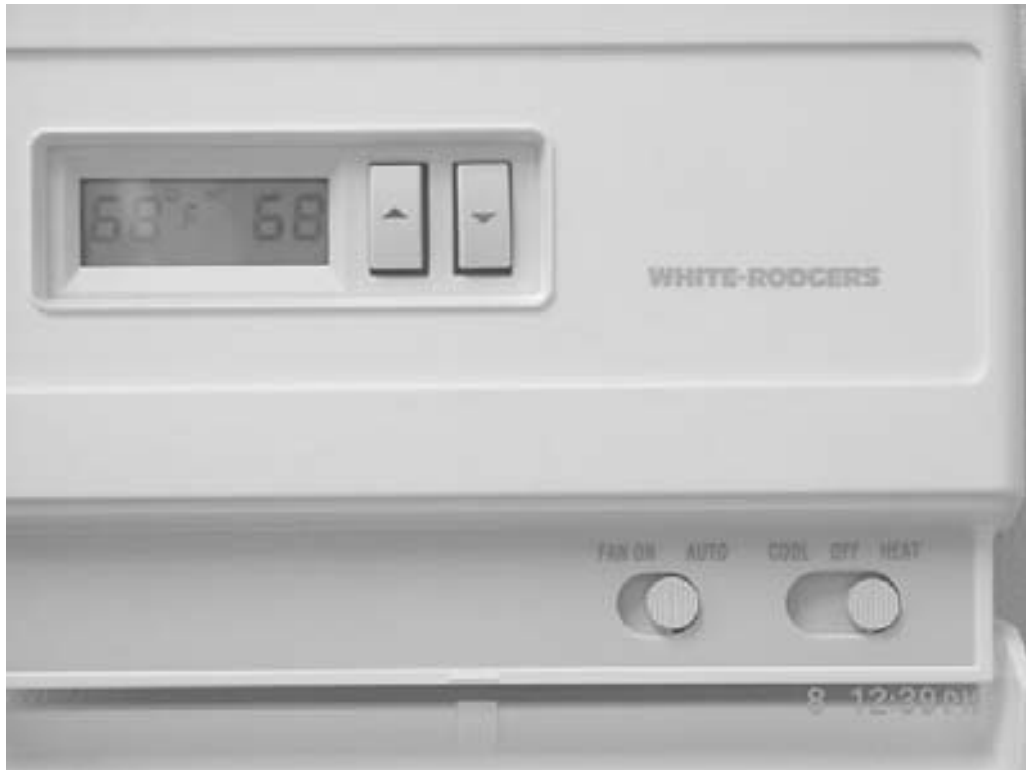
Picture 9

Modular Classroom Thermostat Note Fan Setting to “Auto”

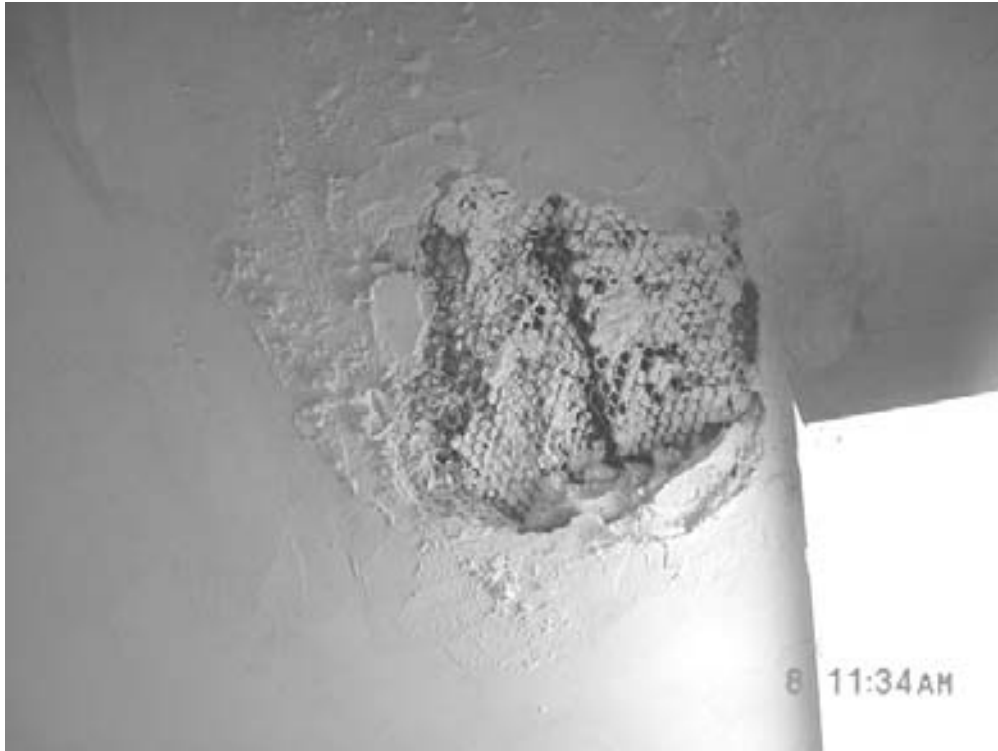
Picture 10

Water-damaged ceiling plaster, which is evidence of water penetration, was observed in the teacher's workroom, which is (Picture 10). Water-damaged building materials can provide a source of mold and should be replaced or repaired after a water leak is discovered and repaired.

Water Damaged Ceiling Plaster in Teacher's Workroom

8. Ensure roof leaks are repaired and repair/replace any remaining water-stained ceiling tiles and/or plaster. Examine the area above and around these areas for mold growth.
Disinfect areas of water leaks with an appropriate antimicrobial.

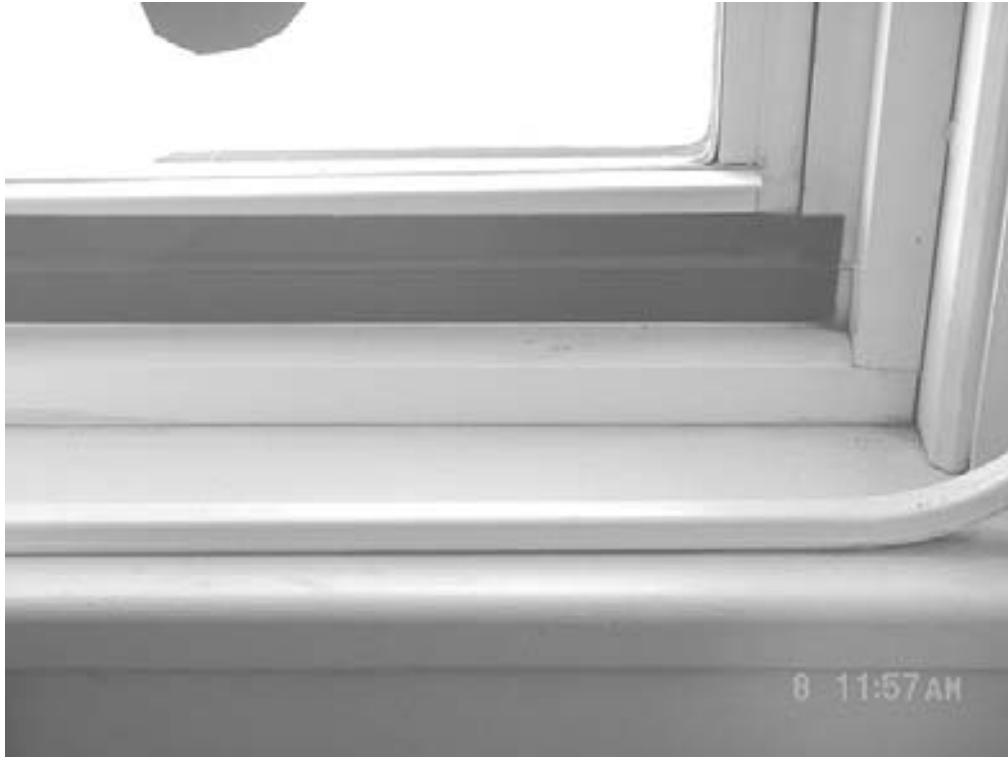
Picture 11

In a number of classrooms windows do not close completely, which allows for drafts and moisture penetration (Picture 11). Repeated water damage can result in mold colonization of window frames and porous materials. Once mold has colonized these materials, they are difficult to clean and should be replaced.

Classroom Window That Does Not Close Properly Sealed With Tape to Reduce Drafts

1. Replace/repair window systems throughout the building -wide to prevent water penetration and drafts through window frames. Consider having exterior brick re-pointed and waterproofed to prevent water intrusion. Weatherproofing materials should be applied during periods when the school is not occupied.
2. Consider installing local exhaust vents in teacher’s workrooms to help reduce excess heat and odors from office equipment.

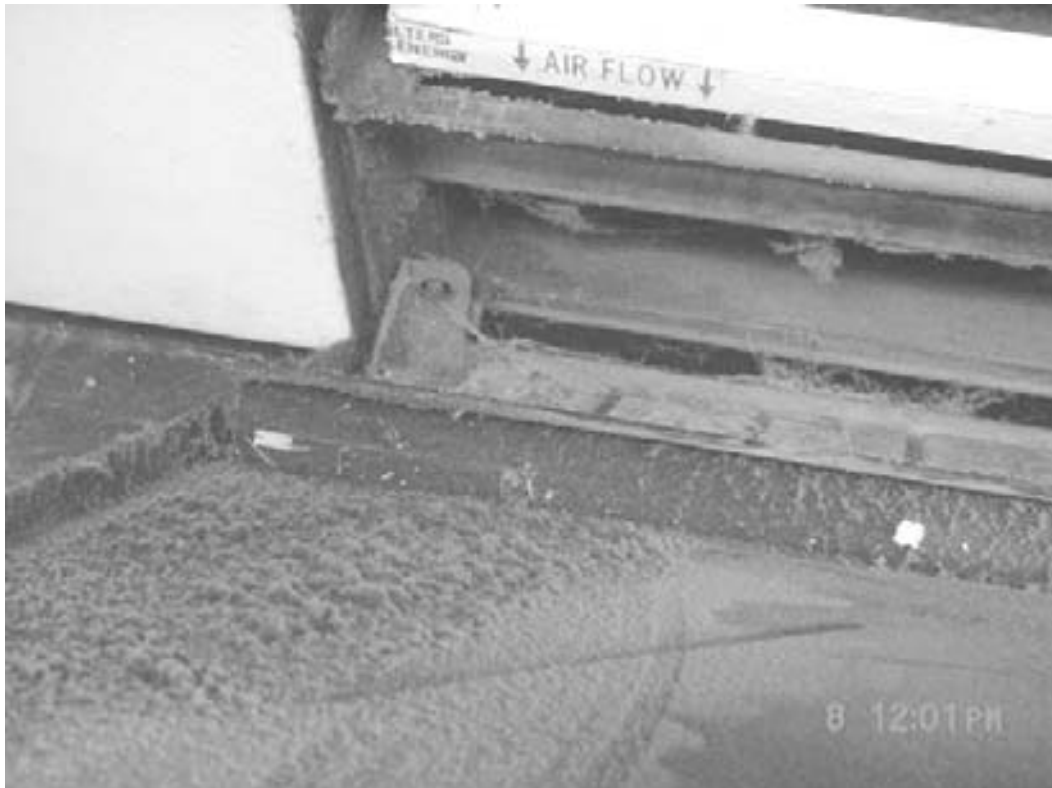
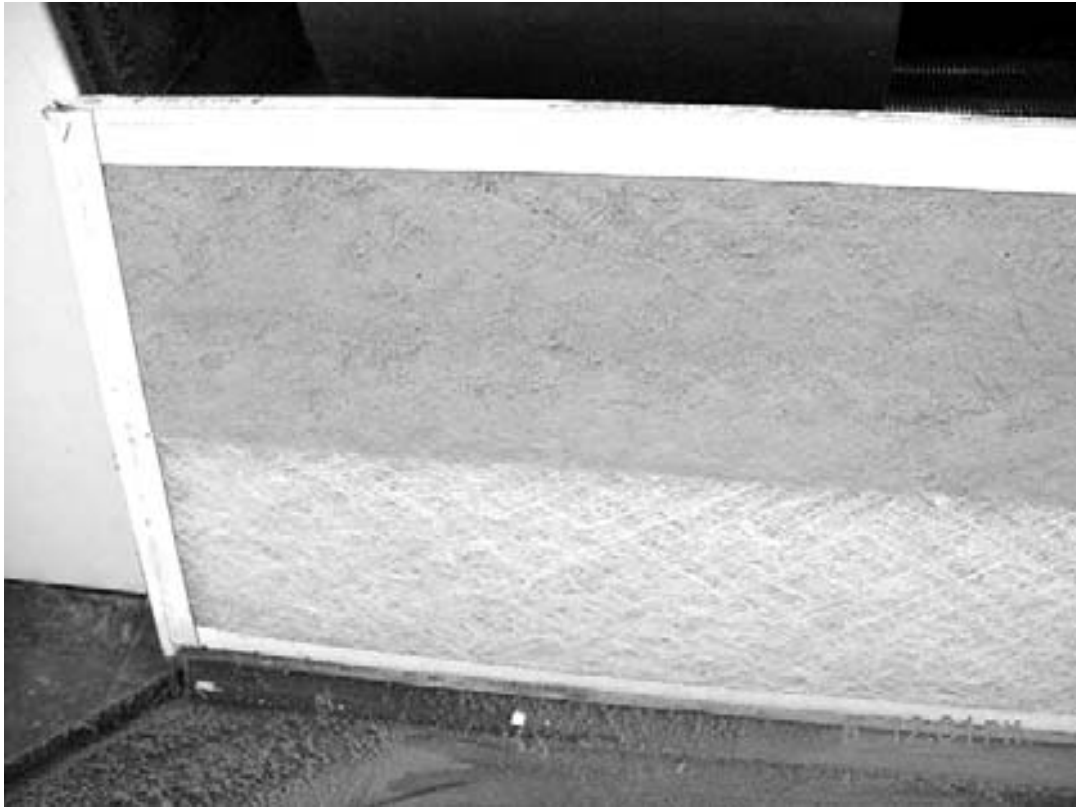
Several other conditions were that can affect indoor air quality noted during the assessment. A number of univents had accumulated dust, cobwebs and debris within the air handling chambers (Pictures 12 and 13). In order to avoid this equipment serving as a source of aerosolized particulates, the air handling sections of the univents and AHUs should be regularly cleaned (e.g. during regular filter changes). A number of exhaust vents in classrooms and restrooms had accumulated dust (Picture 14). If exhaust vents are not functioning, backdrafting can occur, which can re-aerosolize dust particles. In addition, these materials can accumulate on flat surfaces (e.g., desktops, shelving and carpets) in occupied areas and subsequently be re-aerosolized causing further irritation. Dust can be irritating to eyes, nose and respiratory tract.

Cobwebs and Dust Accumulation in Classroom Univent

Univent Filter Occluded With Dust and Debris

10. Make repairs to wall damage in classrooms, to prevent the egress of dirt, dust and particulate matter into classrooms.
11. Change filters for air-handling equipment as per the manufacturer's instructions or more frequently if needed. Vacuum interior of units prior to activation to prevent the aerosolization of dirt, dust and particulates. Ensure filters fit flush in their racks with no spaces in between allowing bypass of unfiltered air into the unit.

12. Clean univent return vents and exhaust vents periodically of accumulated dust.
13. Relocate or consider reducing the amount of materials stored in classrooms to allow for more thorough cleaning. Clean items regularly with a wet cloth or sponge to prevent excessive dust build-up.

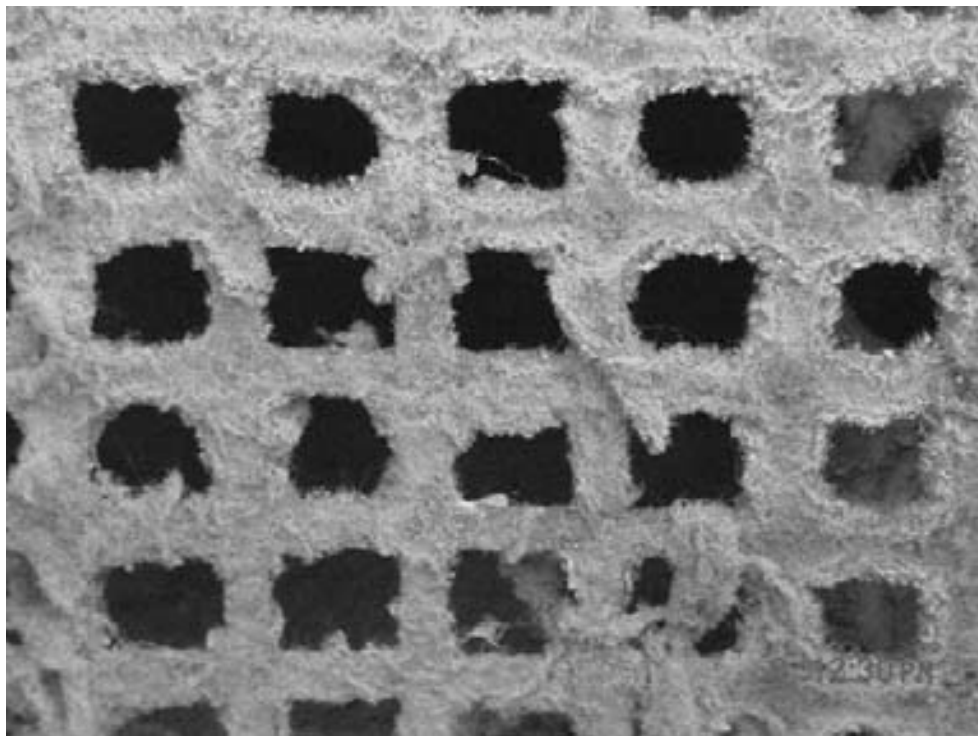
Picture 14

Classroom Exhaust Vent With Accumulated Dust

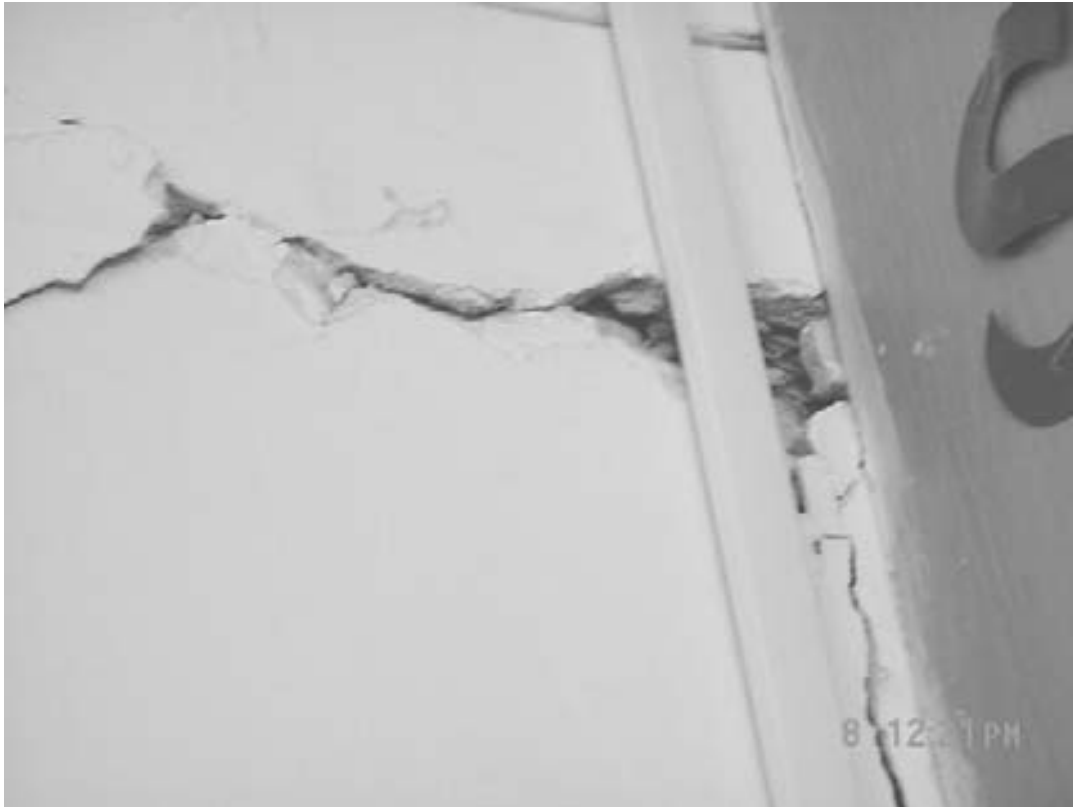
Picture 15

Several rooms had damaged walls (Picture 15). These breaches can provide a pathway for the movement of drafts, dusts and particulate matter between rooms and floors.

Damaged Wall in Classroom

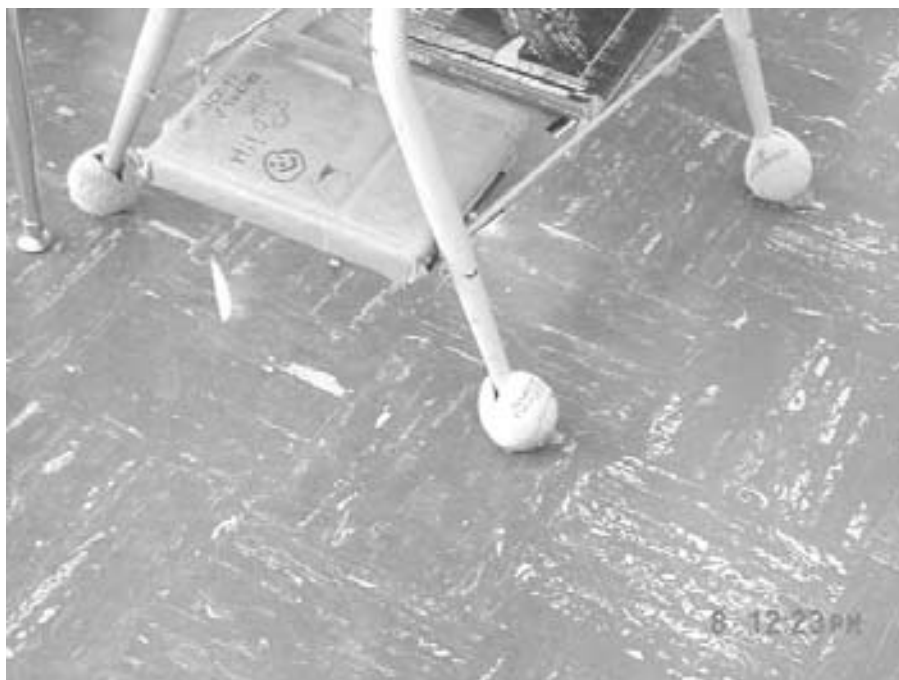
Picture 16

In an effort to reduce noise from sliding chairs, tennis balls were sliced open and placed on chair legs (Picture 16). Tennis balls are made of a number of materials that are a source of

respiratory irritants. Constant wearing of tennis balls can produce fibers and to off-gas TVOCs. Tennis balls are made with a natural rubber latex bladder, which becomes abraded when used as a chair leg pad. Use of tennis balls in this manner may introduce latex dust into the school environment. Some individuals are highly allergic to latex (e.g., spina bifida patients) (SBAA, 2001). It is recommended that the use of materials containing latex be limited in buildings to reduce the likelihood of symptoms in sensitive individuals (NIOSH, 1997). A question and answer sheet concerning latex allergy is attached as [Appendix B](#) (NIOSH, 1998).

Tennis Balls on Chair Legs in Classroom

http://www.state.ma.us/dfa/pesticides/publications/IPM_kit_for_bldg_mgrs.pdf.
16. Consider discontinuing the use of tennis balls on chairs to prevent latex dust generation.
